**Flood Control Project Maintenance
Levee Inspections**

Fall 2014 Levee Maintenance Deficiency Summary Report

Reclamation District No. 2085 Kasson

Levee Inspection Report By Mile - Fall 2014

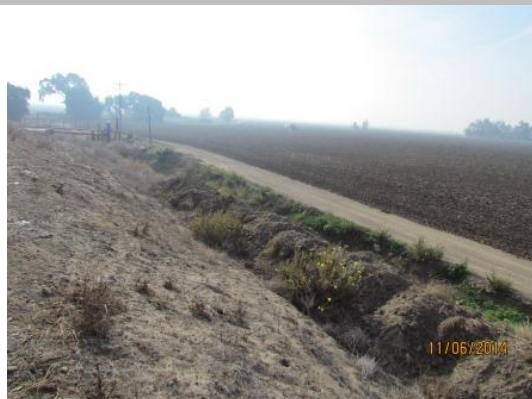
Photo 1 of 1 : FA_2014_RD2085_113_6_20141110_00088.jpg

LM Start	1.28	Rating **	M	Issue No.	6
LM End	1.32	Issue Type +	En	Location *	LS
Category	Earthen Levee			GPS Latitude/Longitude	
				Start	End
Item	Encroachments			37.714265 °	37.714056 °
				-121.289641 °	-121.289069 °
DWR ID	DWR_RD2085_01_s_2012_6				
Action/Comments					
Ditch					
Inspector Comments: Drainage ditch at levee toe.

View of the ditch at the landside levee toe.

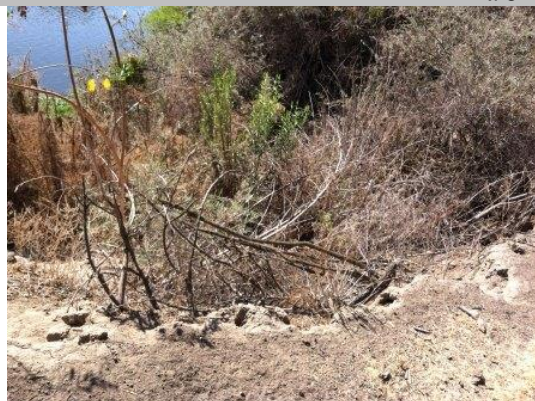
Photo 1 of 1 : SJR2014_RD2085U01RM66.5_1.jpg

LM Start	2.24	Rating **	M	Issue No.	1
LM End	2.26	Issue Type +	Ma	Location *	WS
Category	Supplemental			GPS Latitude/Longitude	
				Start	End
Item	DWR Erosion Survey			37.703094 °	37.703094 °

121.274894 °	121.274894 °
DWR ID					
Action/Comments					
Inspector Comments: 09/20/2013: No significant change in erosion observed. More vegetation at the site. 12/04/2012: The erosion has progressed remarkably toward levee, extended to the up-and downstream of the original pocket erosion. Trees and dense bush are present at the site. Animal burrow holes are visible, and possibly can cause seepage. 09/22/2010: No significant change observed. There is little visibility due to seasonal grass on the berm and slope. 08/18/2009: Site is located on berm; pocket erosion has developed; the site is covered in dense vegetation; there are several relief wells on the landside of the levee; site is Not Rated because berm width is greater than 30 feet; site should be monitored to keep track of erosion progress. [2014 Site ID:RD2085U01RM66.5]

Direct view of the erosion. Note dense vegetation at the site.

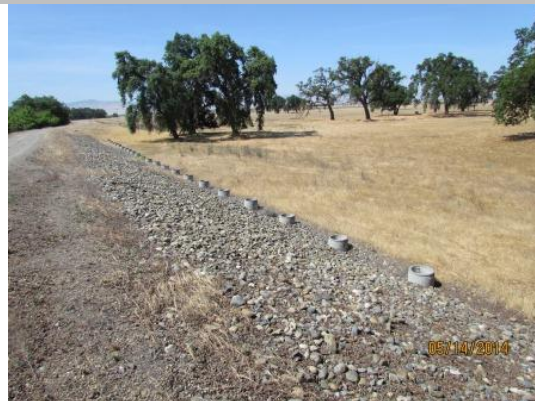
Photo 1 of 1 : FA_2014_RD2085_113_20_20141001_00003.jpg

LM Start	2.51	Rating **	A/W	Issue No.	20
LM End	2.51	Issue Type +	Ob	Location *	LS
Category	Earthen Levee			GPS Latitude/Longitude	
				Start	End
Item	Underseepage Relief Wells			37.702903 °	37.702903 °
				-121.274860 °	-121.274860 °
DWR ID	DWR_RD2085_01_s_2012_20				
Action/Comments

View of the underseepage relief wells at the landside levee toe.

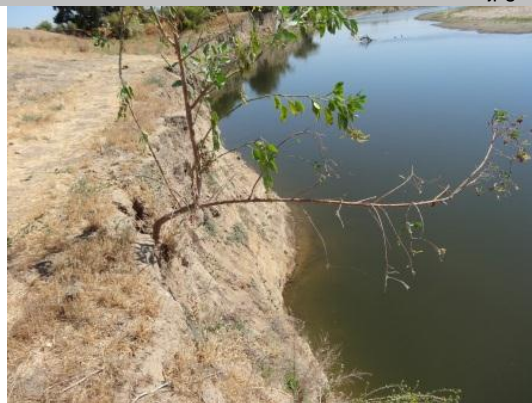
Photo 1 of 1 : SJR2014_RD2085U01RM67.7_1.jpg

LM Start	3.58	Rating **	A/W	Issue No.	2
LM End	3.71	Issue Type +	Ma	Location *	WS
Category	Supplemental			GPS Latitude/Longitude	
				Start	End
Item	DWR Erosion Survey			37.688545 °	37.688545 °
				-121.276298 °	-121.276298 °
DWR ID					
Action/Comments					
Inspector Comments: 7/17/2014: No significant change observed. 09/10/2013: No significant change observed. 12/04/2012: This site has been documented before, and a cost estimate to repair has been prepared dated 05/09/2010. The fresh cut shows the erosion is developing. The berm width is at least 42 feet. Sticks were placed at three locations along the river bank, with 3 sticks 5 feet apart at each location. [2014 Site ID:RD2085U01RM67.7]

Direct view of the erosion.

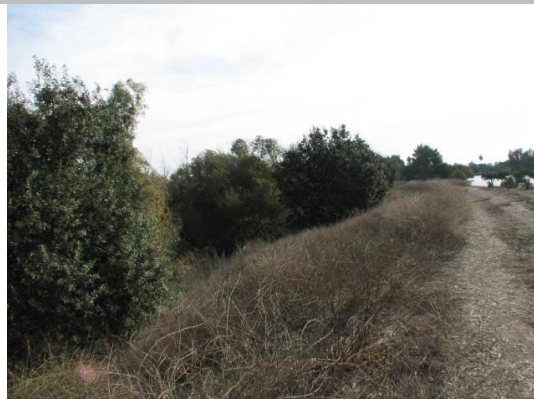
Photo 1 of 1 : FA_2014_RD2085_113_54_20141001_00015.jpg

LM Start	4.18	Rating **	M	Issue No.	54
LM End	4.45	Issue Type +	Ma	Location *	WS
Category	Earthen Levee			GPS Latitude/Longitude	
				Start	End
Item	Vegetation			37.681886 °	37.681332 °
				-121.272333 °	-121.267518 °
DWR ID	DWR_RD2085_01_s_2012_54				
Action/Comments					
Remove the wild growth other than native grasses from the levee slopes.

11/03/2011 Waterside vegetation needs to be maintained on the top 20' of the waterside slope.

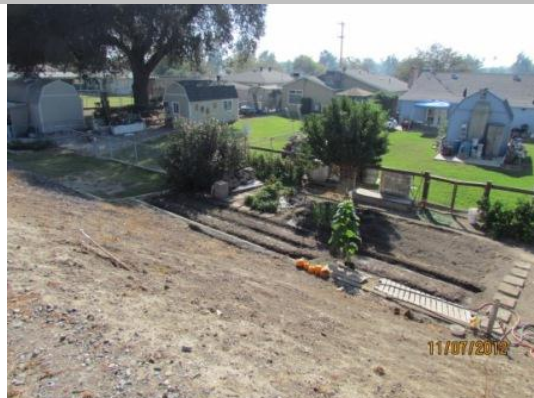
Photo 1 of 1 : FA_2014_RD2085_113_33_20141001_00007.jpg

LM Start	4.32	Rating **	M	Issue No.	33
LM End	4.37	Issue Type +	En	Location *	LS
Category	Earthen Levee			GPS Latitude/Longitude	
				Start	End
Item	Vegetation			37.681863 °	37.681640 °
				-121.269856 °	-121.269046 °
DWR ID	DWR_RD2085_01_s_2012_33				
Action/Comments					
Landscaping

Updated photo of encroachments on landside toe.

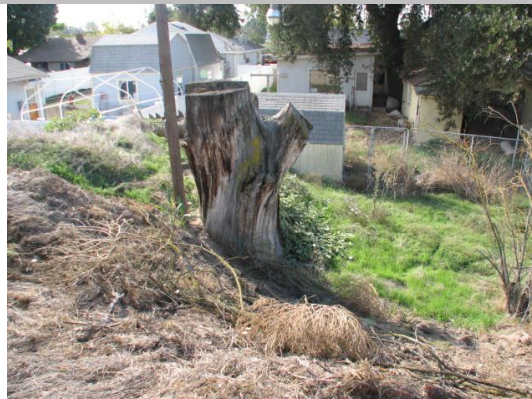
Photo 1 of 1 : FA_2014_RD2085_113_32_20141001_00006.jpg

LM Start	4.38	Rating **	N	Issue No.	32
LM End	4.38	Issue Type +	Ma	Location *	LS
Category	Earthen Levee			GPS Latitude/Longitude	
				Start	End
Item	Trim / Thin Trees			37.681605 °	37.681605 °
				-121.268882 °	-121.268882 °
DWR ID	DWR_RD2085_01_s_2012_32				
Action/Comments					
Tree stumps.

11/03/2011 Large stump on landside slope.

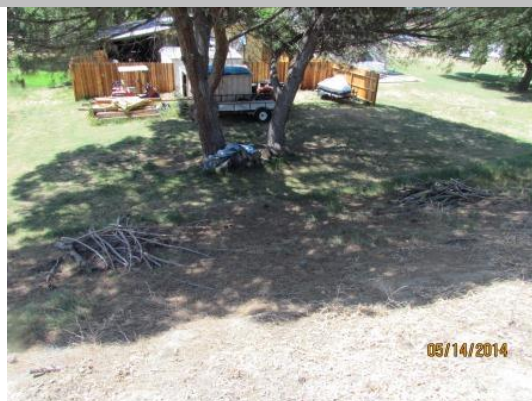
Photo 1 of 1 : FA_2014_RD2085_113_17_20141001_00002.jpg

LM Start	4.51	Rating **	M	Issue No.	17
LM End	4.51	Issue Type +	En	Location *	LS
Category	Earthen Levee			GPS Latitude/Longitude	
				Start	End
Item	Encroachments			37.681158 °	37.681158 °
				-121.266587 °	-121.266587 °
DWR ID	DWR_RD2085_01_f_2013_17				
Action/Comments					
Firewood

View of the firewood stored at the landside levee toe.

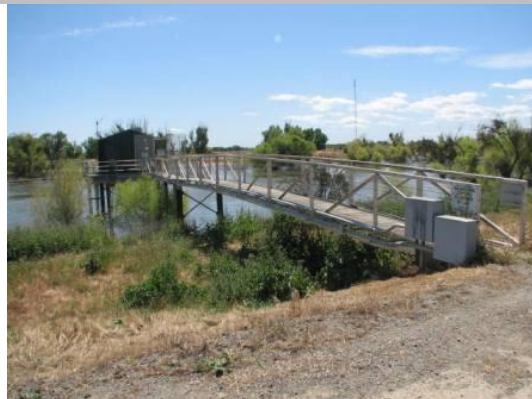
Photo 1 of 1 : FA_2014_RD2085_113_36_20141001_00009.jpg

LM Start	4.70	Rating **	A/W	Issue No.	36
LM End	4.70	Issue Type +	En	Location *	WS
Category	Earthen Levee			GPS Latitude/Longitude	
				Start	End
Item	Encroachments			37.679527 °	37.679527 °
				-121.265367 °	-121.265367 °
DWR ID	DWR_RD2085_01_s_2012_36				
Action/Comments					
Building					
Inspector Comments: Monitoring station on waterward side.

04/28/2011 Monitoring station.

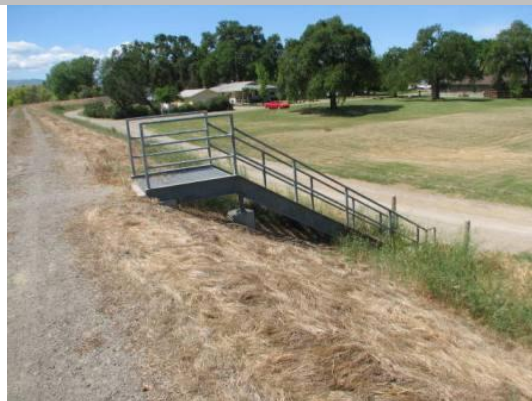
Photo 1 of 1 : FA_2014_RD2085_113_35_20141001_00008.jpg

LM Start	4.70	Rating **	A/W	Issue No.	35
LM End	4.70	Issue Type +	En	Location *	LS
Category	Earthen Levee			GPS Latitude/Longitude	
				Start	End
Item	Encroachments			37.679526 °	37.679526 °
				-121.265367 °	-121.265367 °
DWR ID	DWR_RD2085_01_s_2012_35				
Action/Comments					
Stairway					
Inspector Comments: Stairs for monitoring station on landside slope.

04/28/2011 Stairs on landside slope for monitoring station.

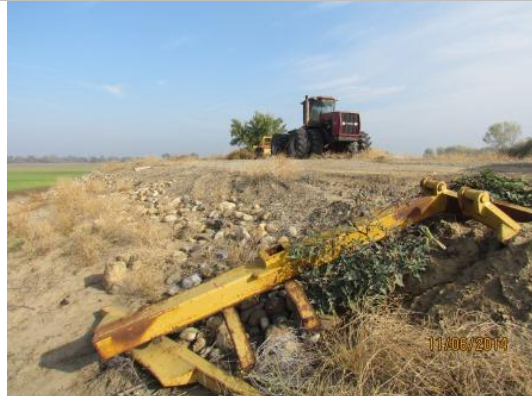
Photo 1 of 1 : FA_2014_RD2085_114_1_20141110_00006.jpg

LM Start	0.68	Rating **	M	Issue No.	1
LM End	0.68	Issue Type +	En	Location *	CR
Category	Earthen Levee			GPS Latitude/Longitude	
				Start	End
Item	Encroachments			37.713838 °	37.713838 °
				-121.269690 °	-121.269690 °
DWR ID	DWR_RD2085_02_s_2012_1				
Action/Comments					
Equipment					
Inspector Comments: Heavy equipment is being stored on the levee crown.

View of farming equipment being stored on the levee crown at the end of the spur levee.

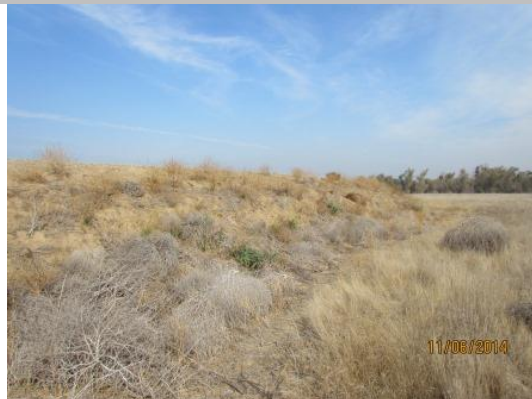
Photo 1 of 1 : FA_2014_RD2085_115_1_20141110_00005.jpg

LM Start	0.21	Rating **	U	Issue No.	1
LM End	0.23	Issue Type +	Ma	Location *	WS
Category	Earthen Levee			GPS Latitude/Longitude	
				Start	End
Item	Erosion / Bank Caving			37.682798 °	37.683052 °
				-121.262059 °	-121.261851 °
DWR ID	DWR_RD2085_03_s_2014_1				
Action/Comments					
Schedule repair of erosion site prior to the next inspection. Inspector Comments: Erosion of the waterside levee slope has been observed. The erosion is about 3 feet tall vertical from the slope to the base of projected levee toe.

View of the erosion at the waterside levee toe.
